Date | 11-30-2016
To | Chisago Lakes LID Board of Managers
cc | Jerry Spetzman
From | Greg Graske

Regarding | Summer Channel and Outlet Structure Inspection

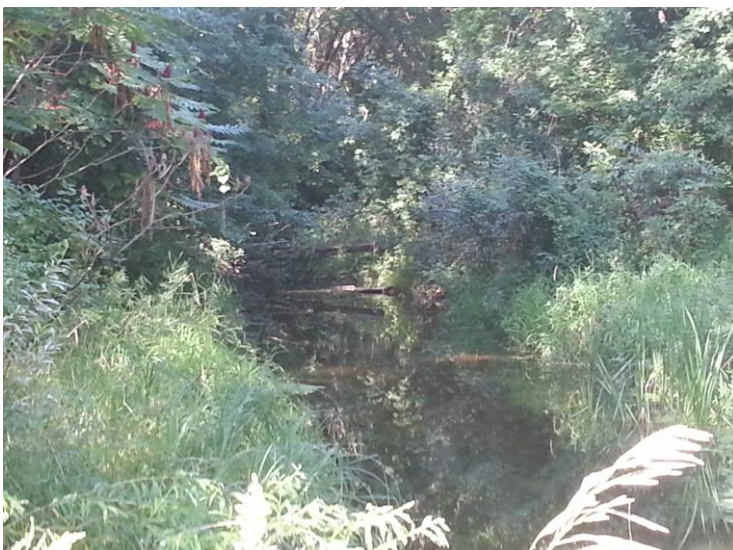
Photos: Left – Woody debris in channel west of Lake Pointe Drive.

- Remove woody debris in channel west of Lake Pointe Drive

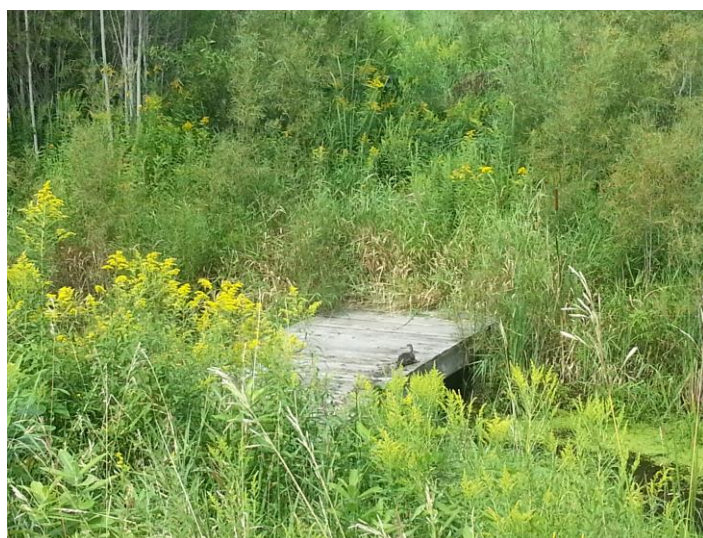
As noted in the 2015 spring inspection report, a bridge crossing has been constructed at about the halfway point along the channel. It is unclear who constructed this bridge and for what purpose. In the past there have been planks and ladders seen across the channel and it was assumed that this was being used by hunters to gain access to the other side of the channel. The new bridge is much more substantial and would likely create a measurable obstruction during high water flows through the channel. Originally Chisago County Parks had indicated that they would take the bridge, however they have since decided the materials were poor quality and are no longer interested. Since then the District administrator has spoken with the supervisor of the sentence to serve crews. They are planning to have the crews remove and dispose of the bridge sometime this winter after the channel is frozen.

Photos: Left – Bridge over channel.

- Sentenced to serve crews to remove the bridge

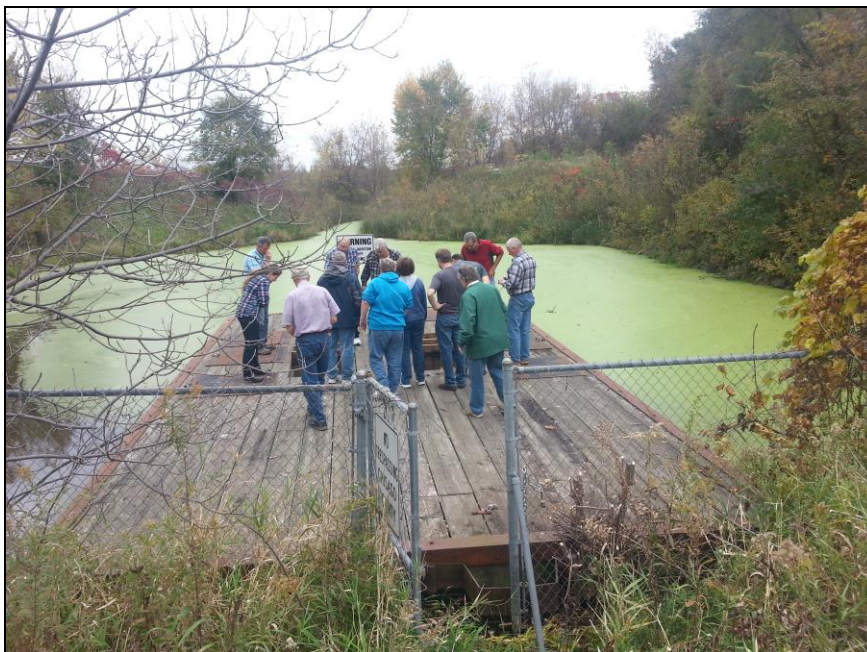
The outlet structure connecting the channel from Chisago Lake to Green Lake was visited. The vegetation along the fence that was noted in the summer report was removed. Mice have been using the gate control boxes as nests. Dryer sheets have been placed in the control boxes and new covers without holes will be made and installed. The gates were tested and operational.

Photos: Outlet Control Structure

- Install new covers on control boxes
- Tighten loose nut with Allen wrench

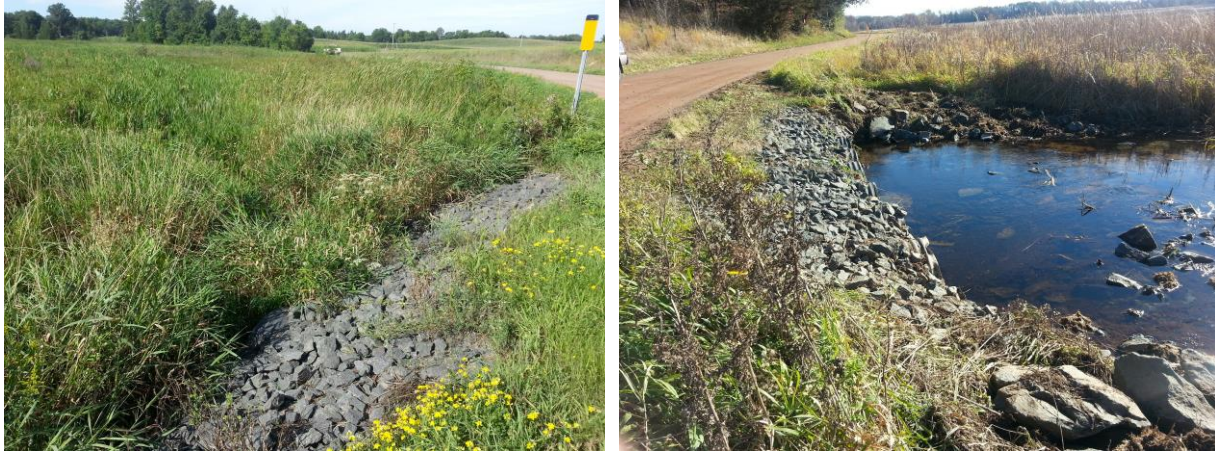
The Swamp Lake outlet pipes under County Road 80 were visited. This location has 7 pipes under the road to convey flow. As noted in past inspections, vegetation was starting to get thick near several of the culverts. The District hired a contractor to remove this vegetation and the work has been completed.

Photo: Left - pipes leaving Swamp Lake before maintenance, Right – pipes after maintenance

- Contractor removed vegetation build up
